International Conference on
Carbon Fibre Applications

MECHANISMS OF FRACTURE IN FIBRE REINFORCED STRUCTURES*

Heinrich W. Bergmann**

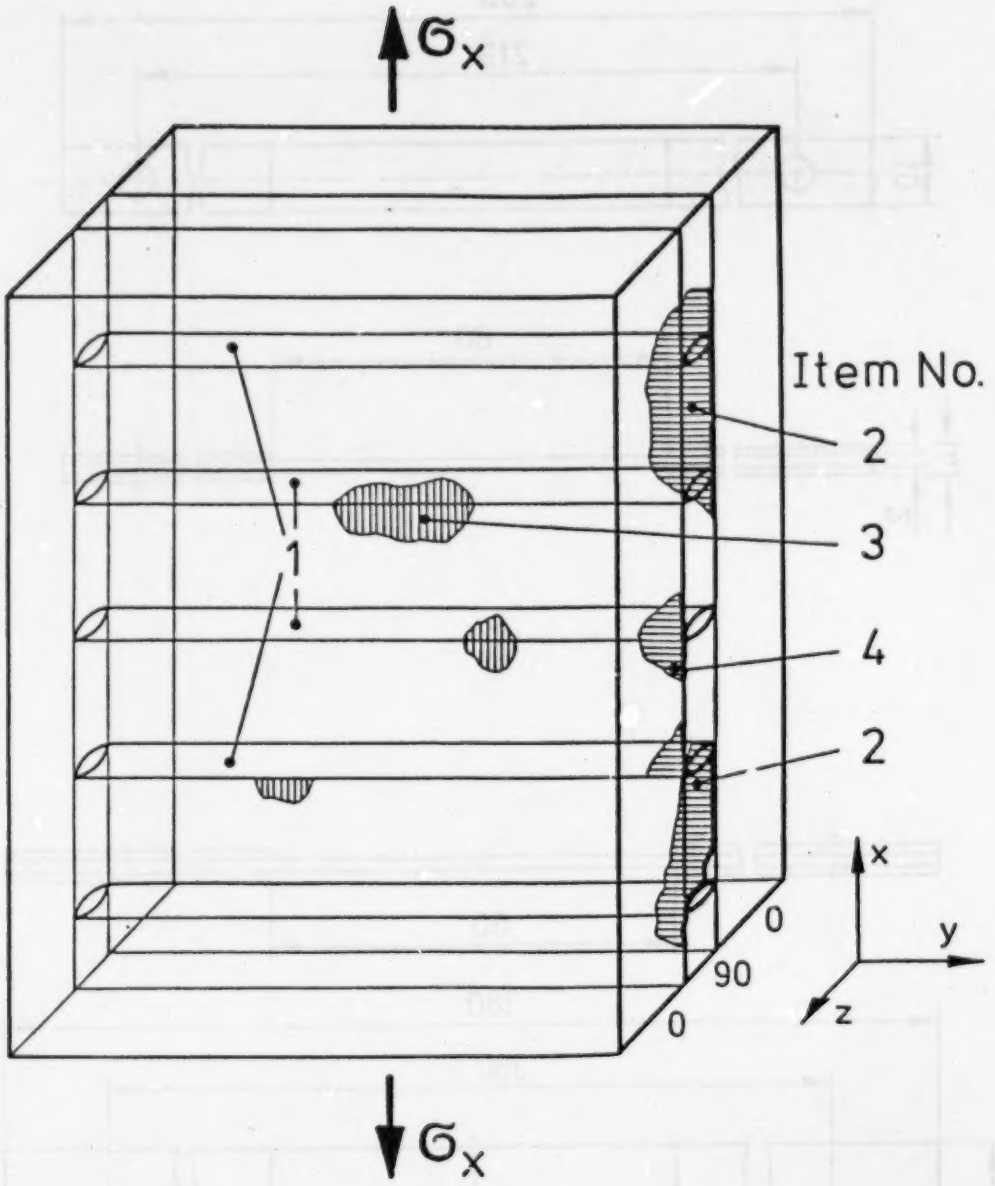
Fig. 2

Close observation of unnotched specimens tested under cyclic tension loads indicates that the progression of events follows a more or less distinct pattern. The first discernable damage usually are microcracks at certain intervals in the crossplies of the laminates. With increasing cycles more microcracks develop which, at the interfaces with neigboring plies, tend to turn and to form small delaminations both inside and, especially, at the free edges of the laminate. Additional delaminations emanate from the locations of fiber or fiber bundle breaks and lead to a damage state depicted in Figure 2.

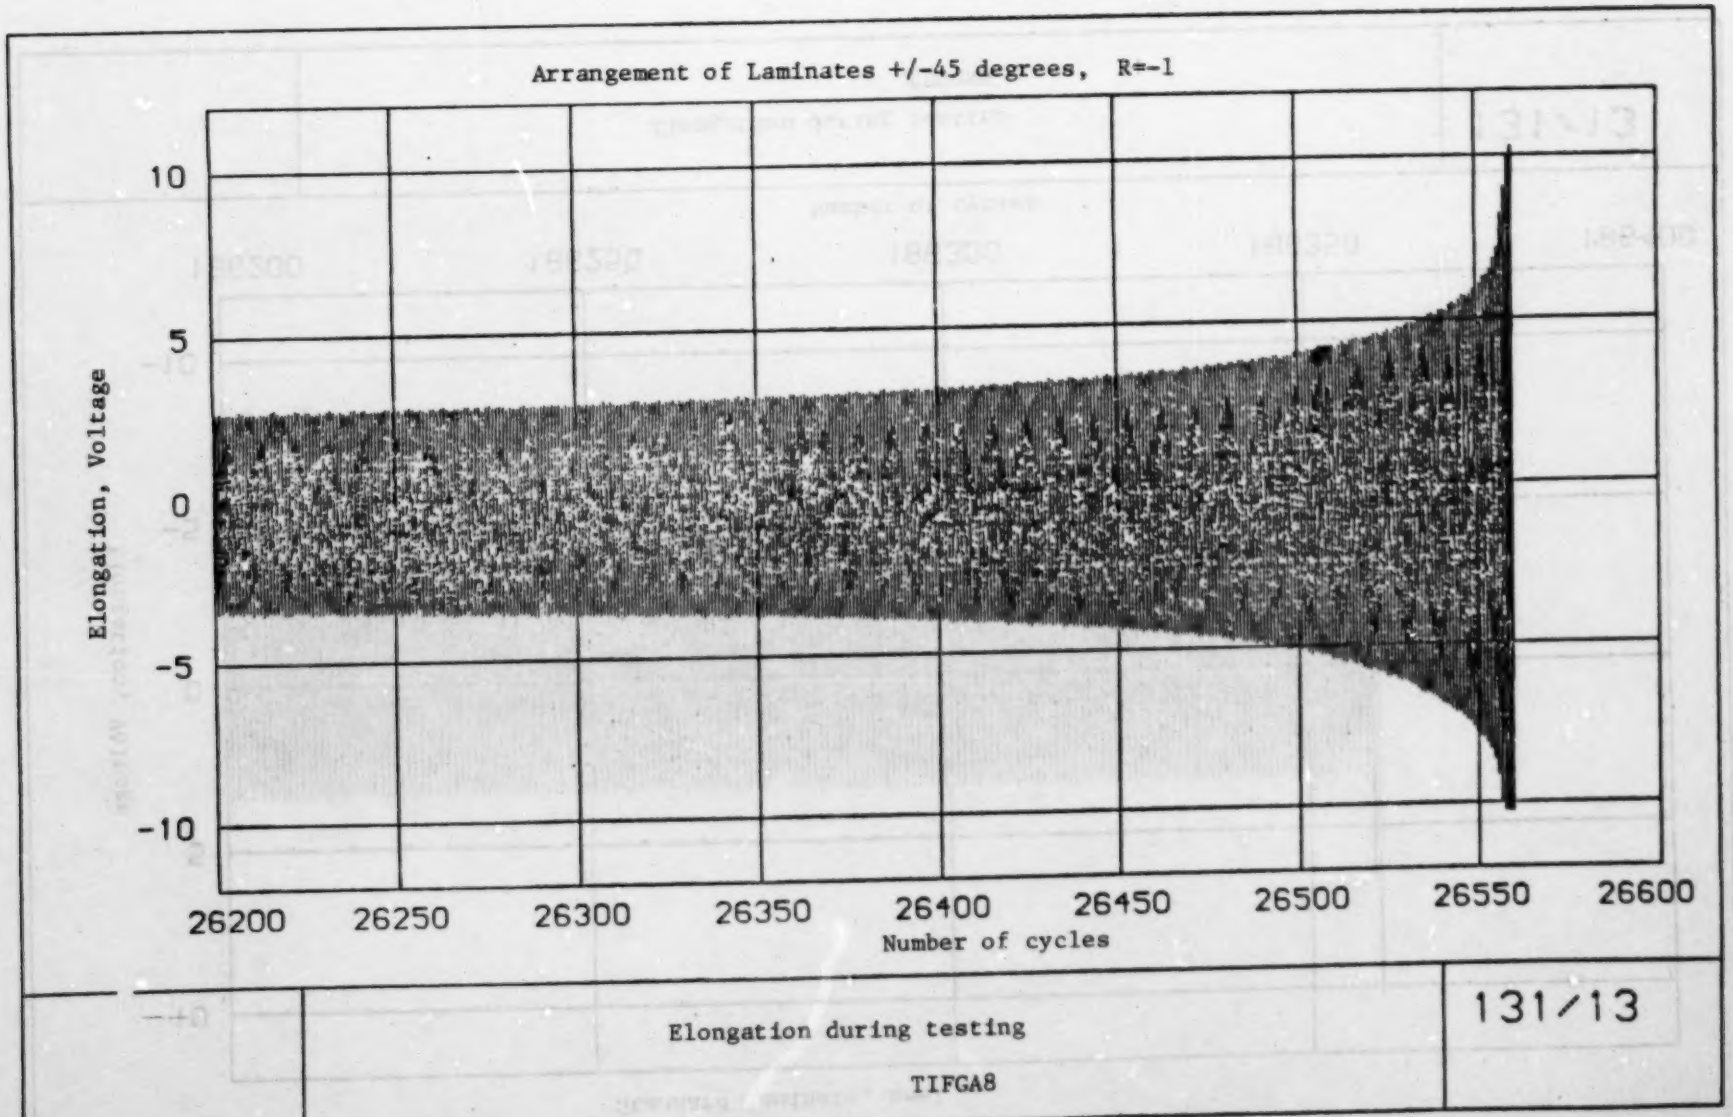
Fig.3

Accompanying the gradually increasing damage state is a noticeable reduction of the overall laminate stiffness. Depending on the stacking order, this reduction may be as pronounced as shown in Figure 3 for a matrix-controlled $[\pm 45]_{2s}$-laminate, or as subtle as in the case of the fiber-controlled $[0_2,+45,0_2,-45,0,90]_s$-laminate shown in Figure 4. In both instances, however, a particularly critical combination of local failure modes develops finally which leads to a rapid deterioration of the stiffness in only a few additional cycles and to what is commonly called "sudden death" of the specimen.

Arrangement of Laminates +/-45 degrees, R=-1
10
5
0
-5
-10
Elongation, Voltage
26200
26250
26300
26350
26400
26450
26500
26550
26600
Number of cycles
Elongation during testing
TIFGA8
131/13

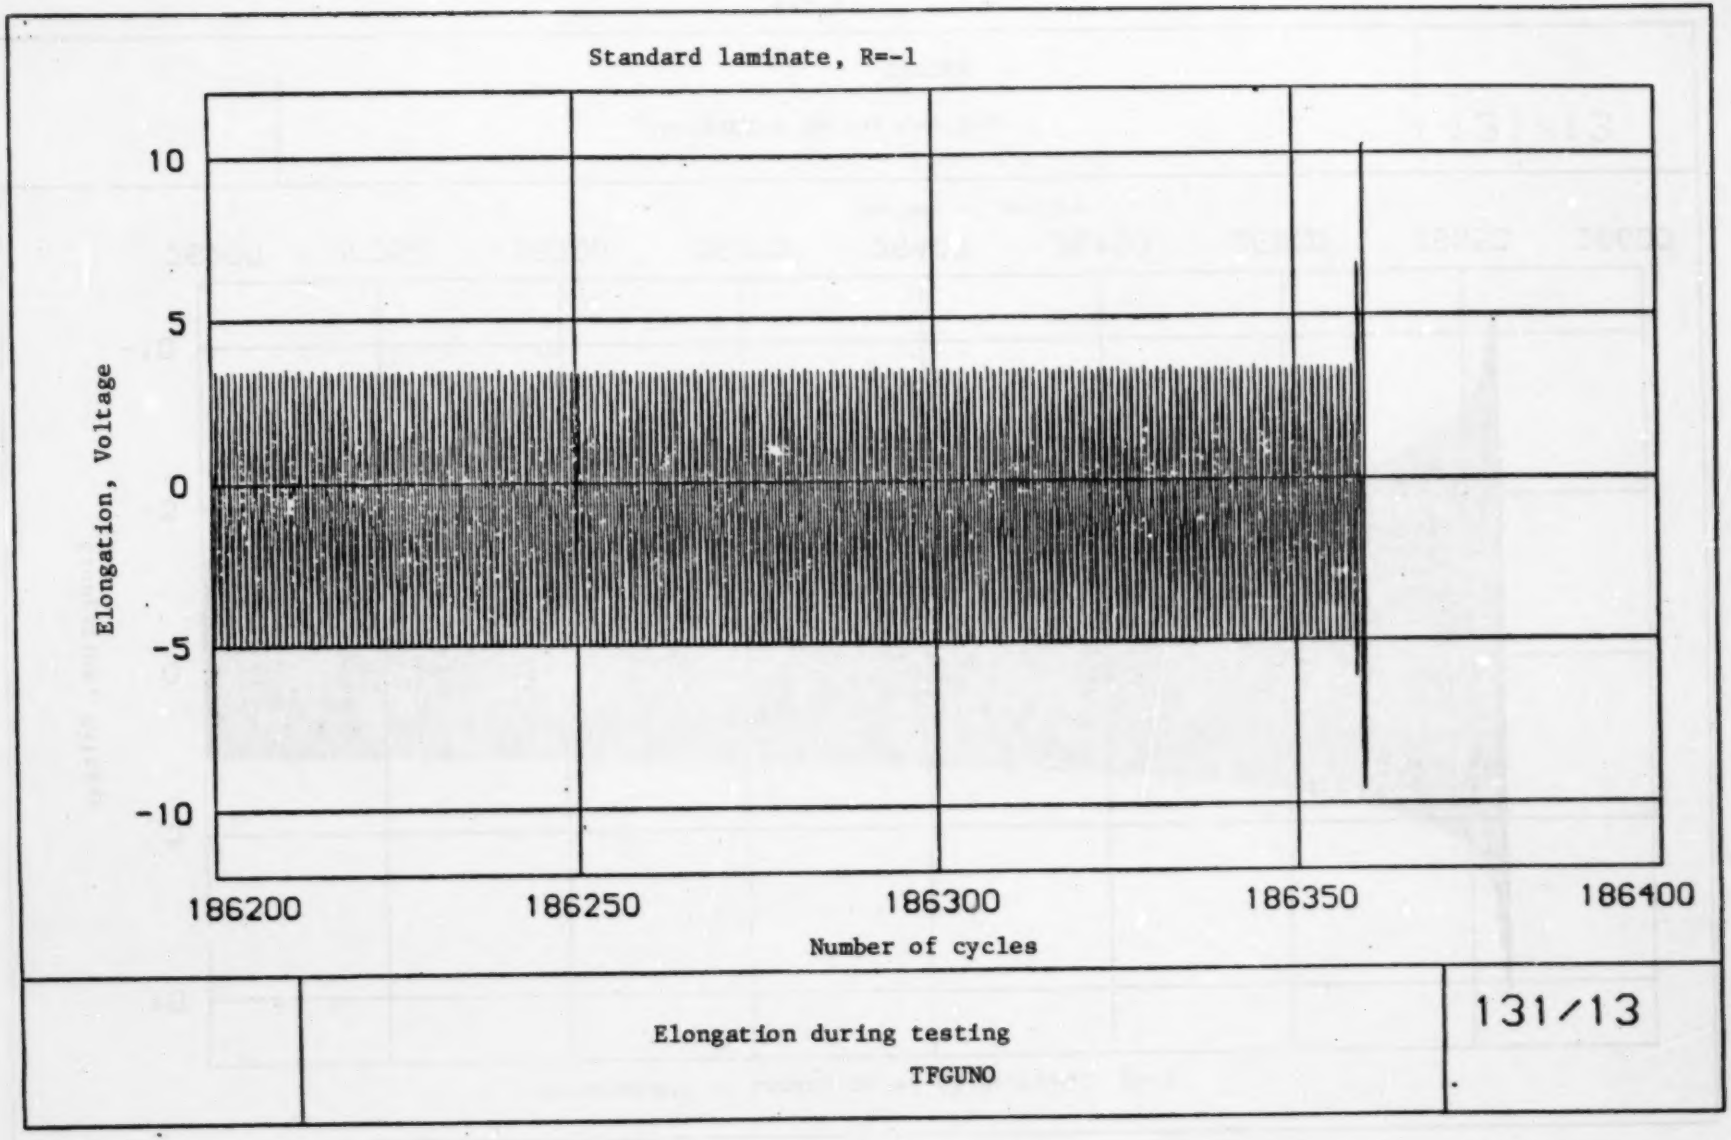
Fig. 4

Standard laminate, R=-1
10
5
0
-5
-10
Elongation, Voltage
186200
186250
186300
186350
186400
Number of cycles
Elongation during testing
TFGUNO
131/13

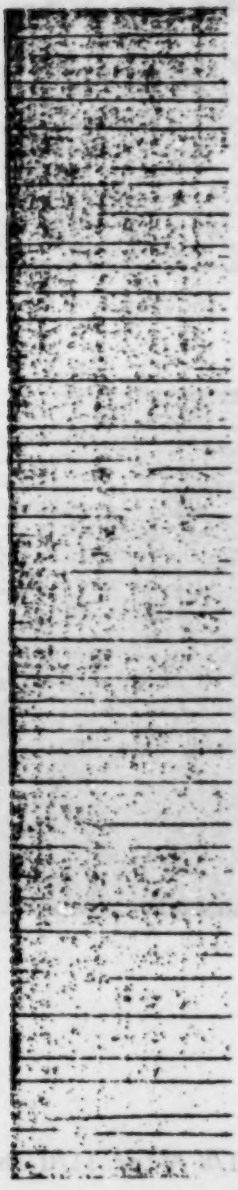
Fig. 5

The normally used epoxy resins exhibit very limited strain capabilities. In addition, the discrepant thermal expansions of the fibers and the resins induce adverse prestresses as a result of the curing process. Under these conditions the formation of microcracks can be expected in those plies of a laminate which are mechanically or thermally stressed beyond the critical strain values of the resin. Typical examples of microcracks observed radiographically in the crossplies of $[0,90]_s$-laminates during a tension test are shown in Figure 5.

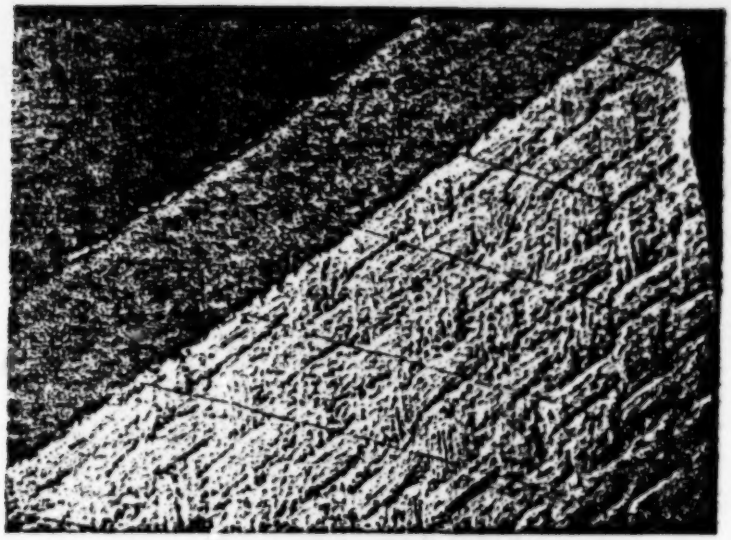
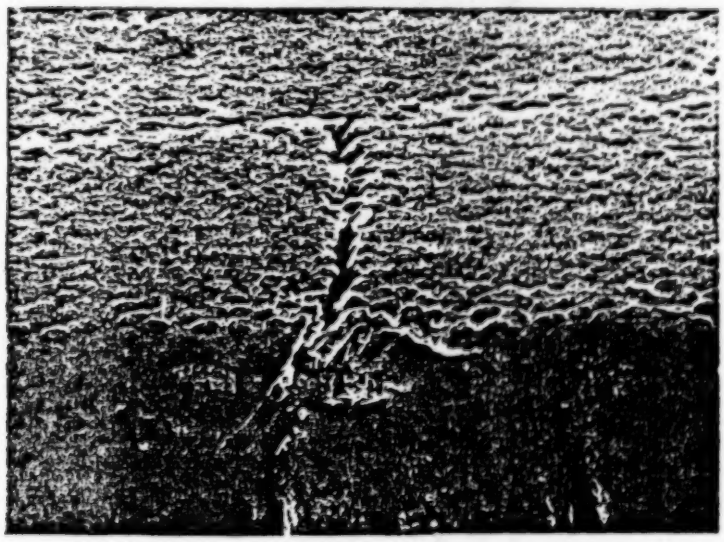
Fig. 6

Repeated exposures to high mechanical loads or to low temperatures will aggravate the state of damage. Figure 6 shows that in $[\pm 45]_{2s}$-specimens subjected to thermal cycles between $+100^{\circ}C$ and $-155^{\circ}C$ the cracks turn at the interfaces of adjacent plies and form local delaminations which tend to grow with increasing

Sample of T3T F 178 After 1170 Thermal Cycles

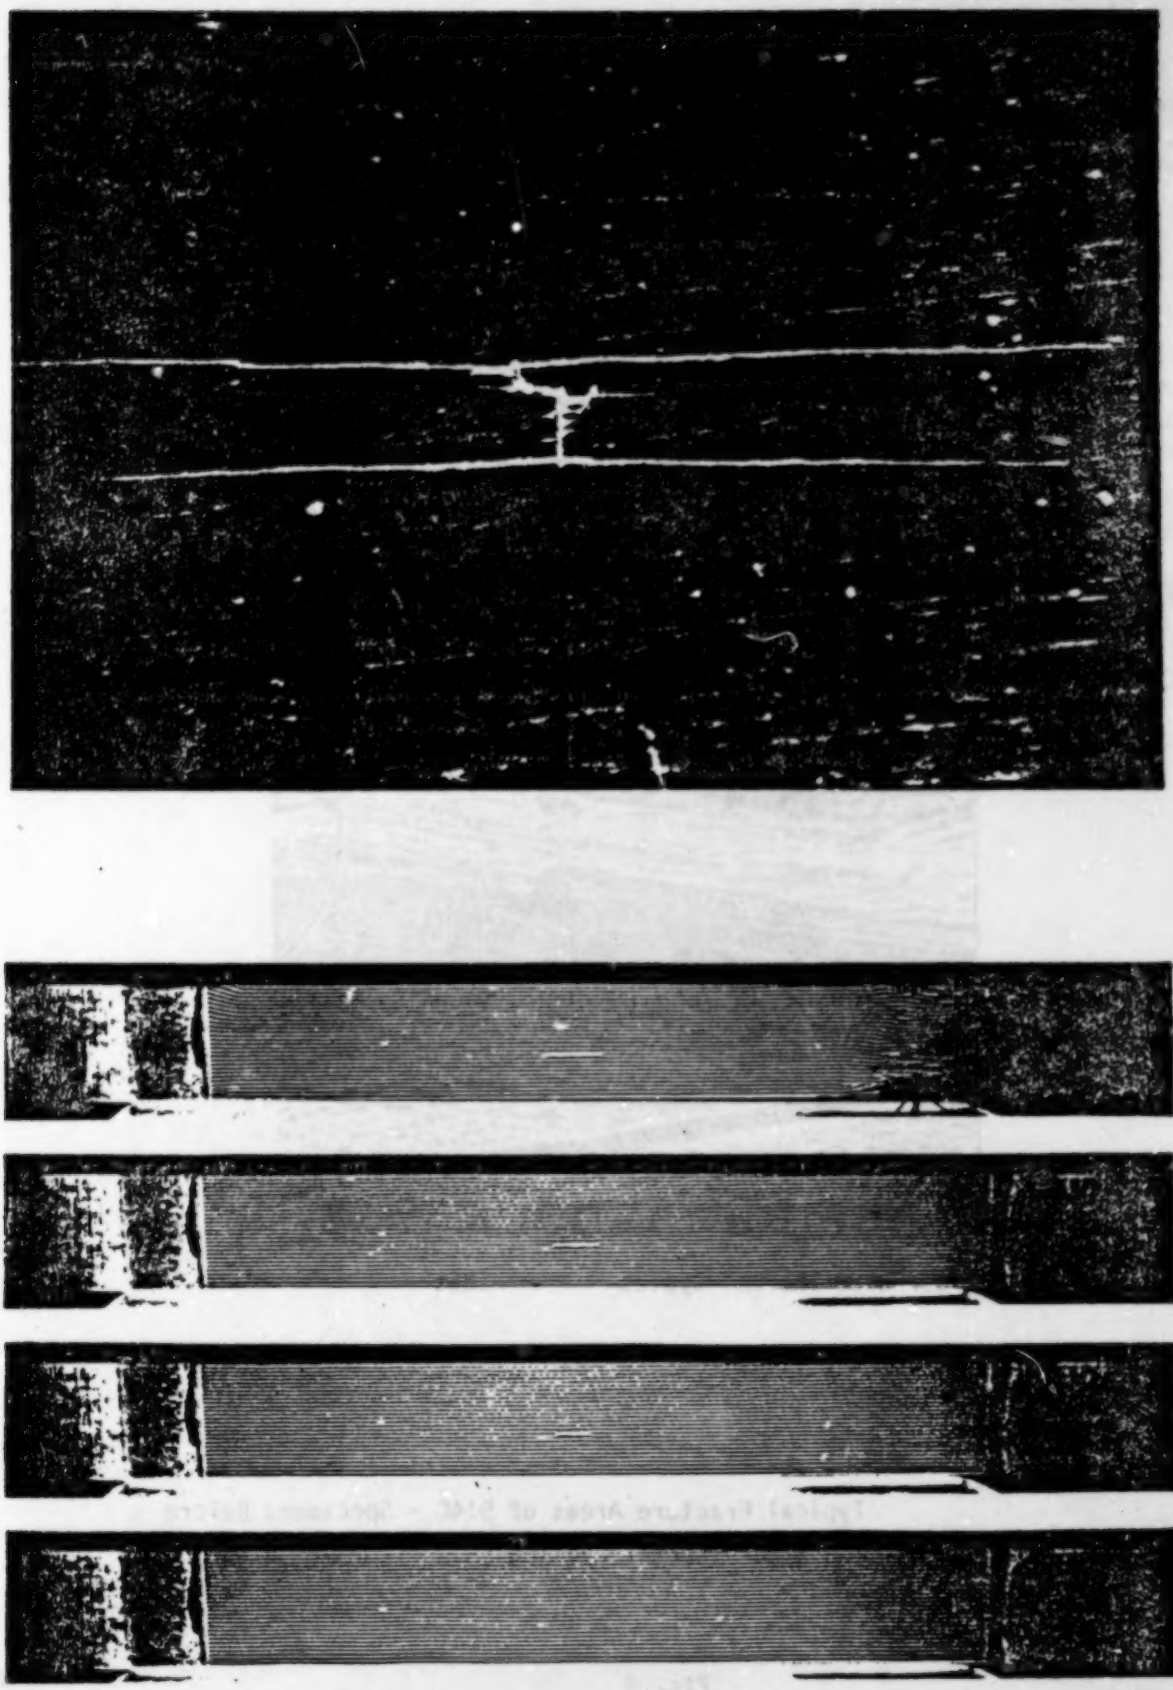
Fig. 7

In highly stressed laminates fibers may rupture prematurely, individually or in small bundles, because of their imperfect shapes or imperfect alignment. Especially in fiber-controlled stacking orders the resulting redistribution of stresses in the vicinity of such discontinuities may initiate the type of local failure modes which affect the fracture behavior of the laminate. Figure 7 depicts the observation of the break of a fairly massive fiber bundle by the grid-reflection technique as well as the associated spalling and cracking of the affected zone.

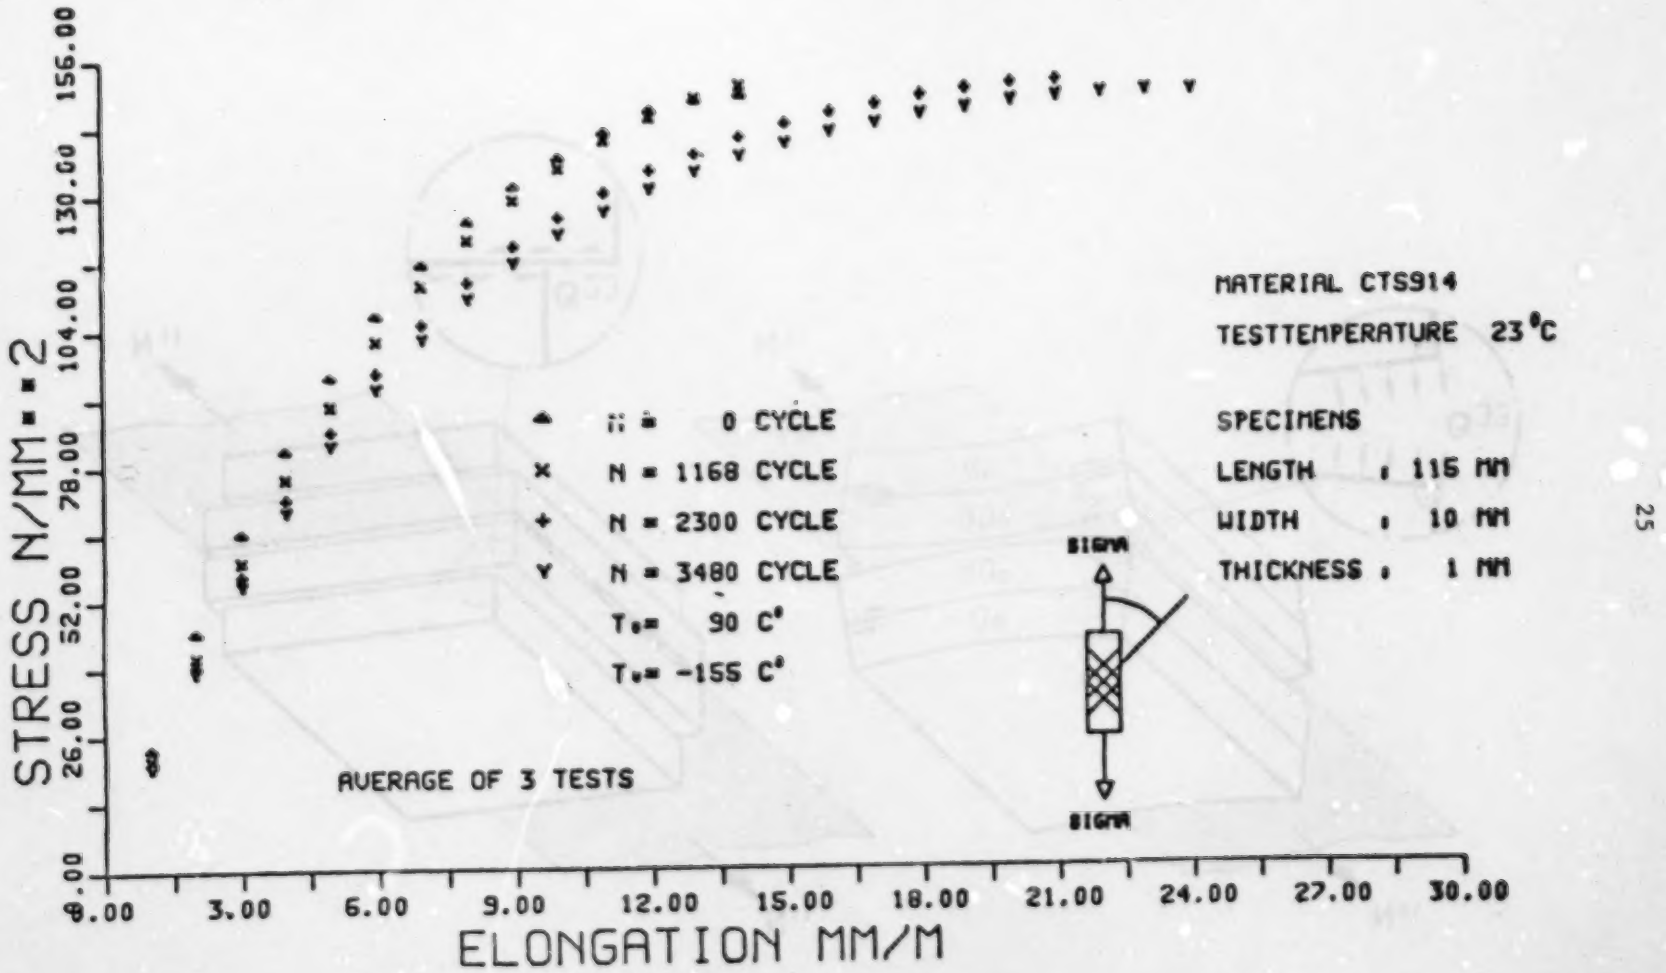
Fig. 9

surfaces after cycling seem to signal the loss of it. It may be expected that similar degradations take place under mechanical loads. As a consequence of progressive debonding, a gradual deterioration of the laminate stiffness might be expected. Figure 9 seems to lend credence to this argument although it is not clear to what extent additional cracking contributes to the stiffness degradation.

Stress-Strain Slope From Tension on $\pm$ 45° CRP After Thermal Cycling

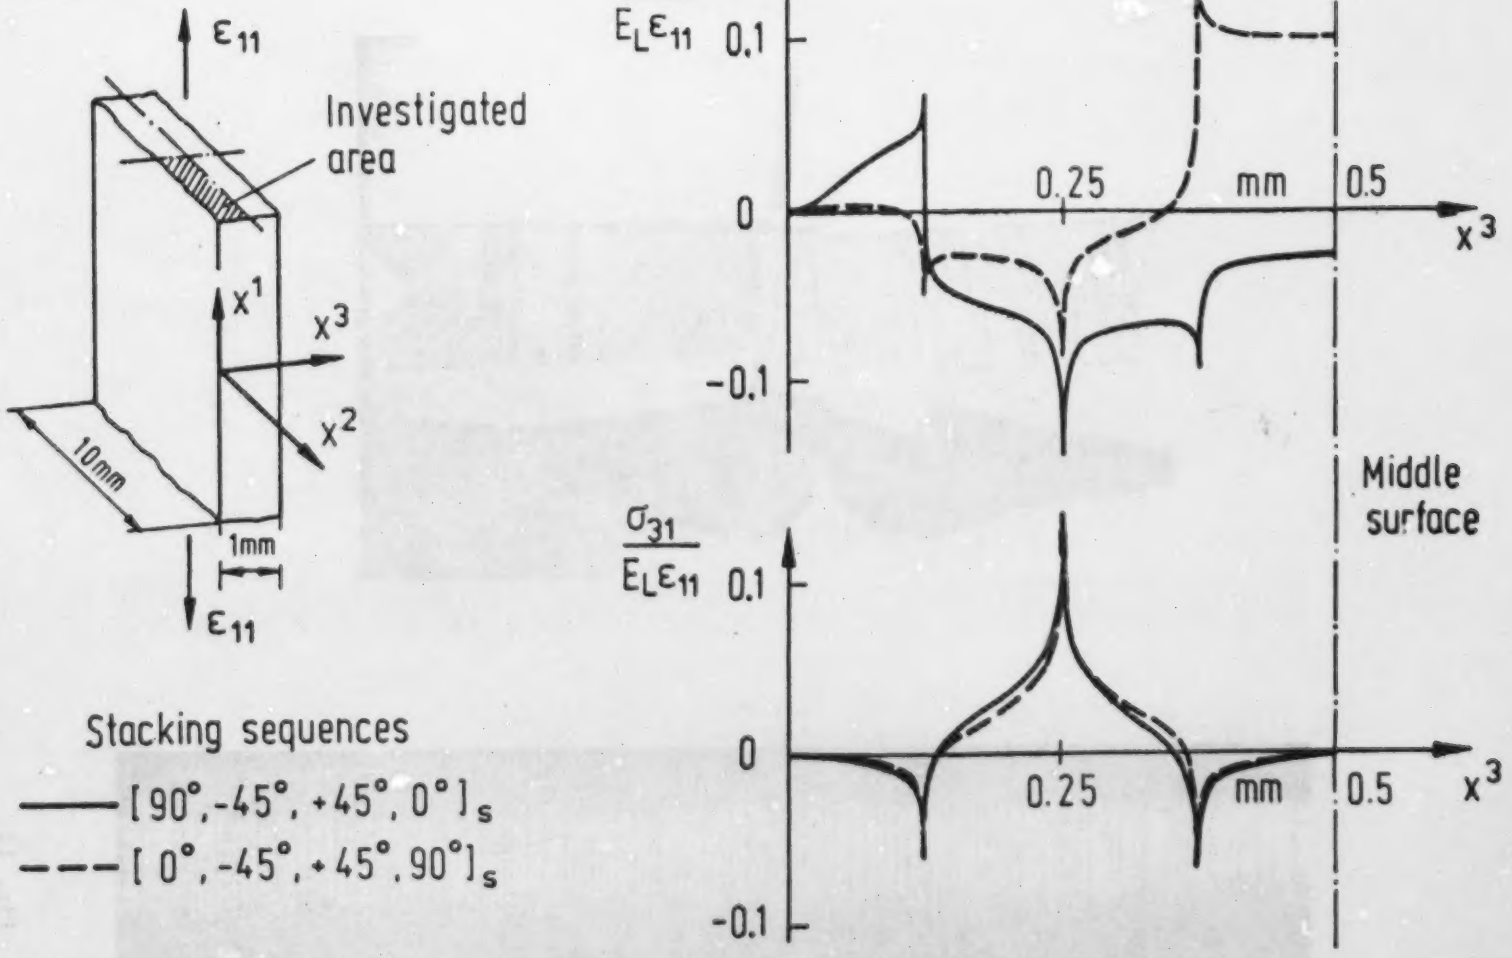
Fig. 11

A very different behavior of the two laminates was observed during fatigue loading with R=+0.1 and an upper stress level of 75 % of their respective static strengths. As expected, microcracking and edge delaminations occurred relatively early in the $[0,\pm45,90]_s$-specimens. Monitored by contrast-enhanced radiography, as shown in Figure 12, the delaminations proceeded from both sides toward the center of the specimen until, shortly before failure, they were separated only by the narrow strip recognizable in Figure 13. The $[90,\pm45,0]_s$- specimens, in contrast, exhibited relatively minor evidence of damage. The appearance of a typical free edge, shortly before failure, is shown in Figure 14. Incipient delaminations are recognizable between those plies where, according to Figure 11, the internal stresses are most severe.

Free edge stresses under axial tension for different stacking sequences of a laminate

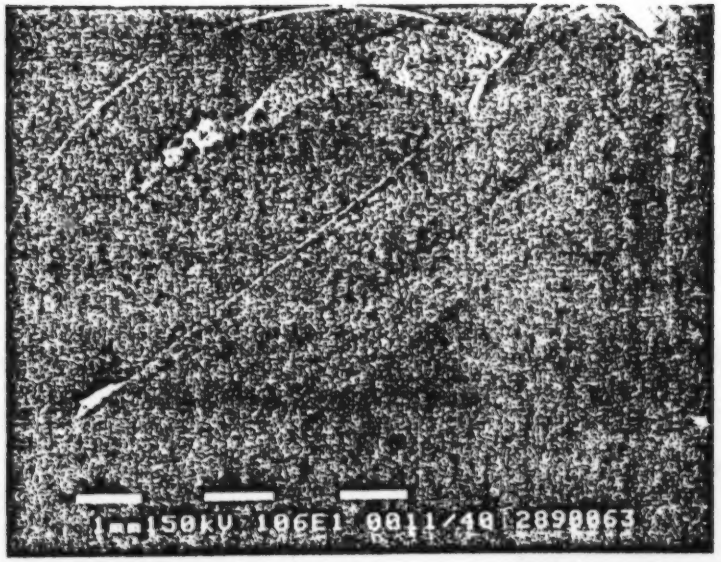
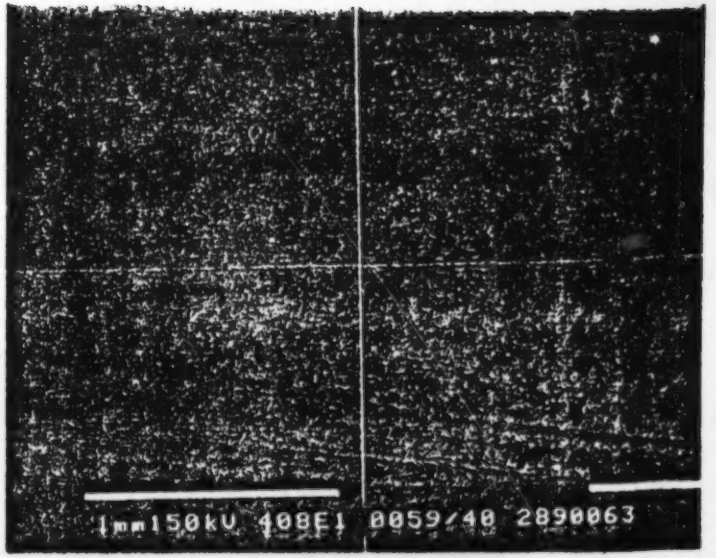
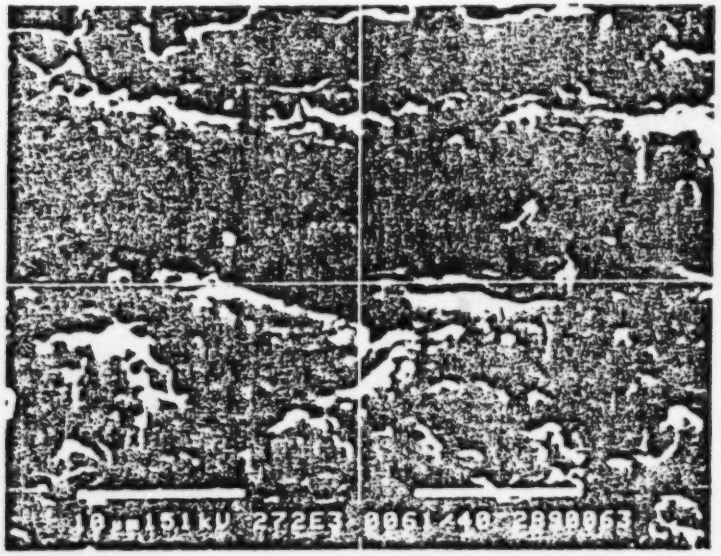
Fig. 15

Figure 15 shows a series of enlargements of the tip of an edge delamination of a $[0_2,+45,0_2,-45,0,90]_s$-laminate which convey an interesting impression of the crack pattern in the matrix material.

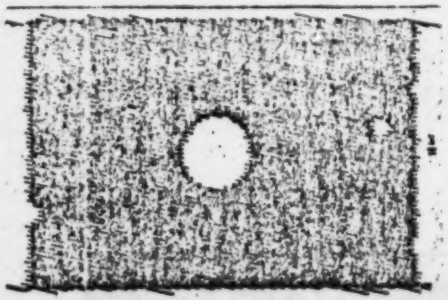
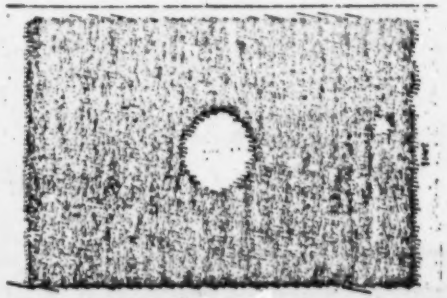
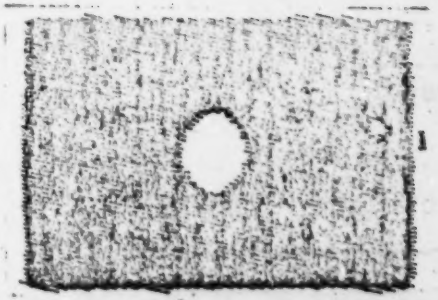
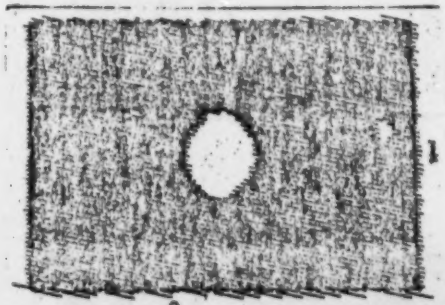
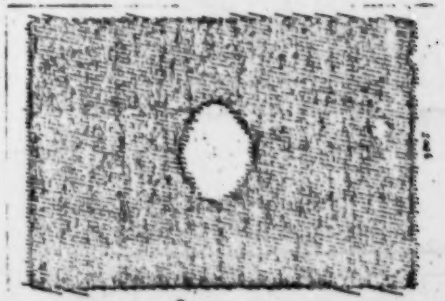
Fig. 16

Figure 16 shows, by means of ultrasonic records, the progressive growth of a delamination under a gradually increasing compressive load in a standard test specimen. The 0.1 mm thick teflon disk was placed between the 90^{o}-plies at the midplane of the specimen. Up to approximately 85 % of ultimate load the delamination is seen to be stable to then grow in the direction of the fibers of the neighboring plies. The same kind of test specimen loaded in tension exbibits a very different behavior. Figure 17 shows that, while the central delamination remains unchanged up to failure of the specimen, edge delaminations occur along the free boundaries at approximately 80 % of ultimate load which subsequently gradually increase. Figure 18, finally, illustrates the response of a test specimen under cyclic load with R=-1 and a stress level of ca. 50 % of its ultimate strength. After 20000 cycles the first evidence of central delamination growth and onset of edge delaminations is noticeable, which gradually increase in severity until failure after 140000 cycles.

Delamination in middle layer of the sample - stat. pressure load

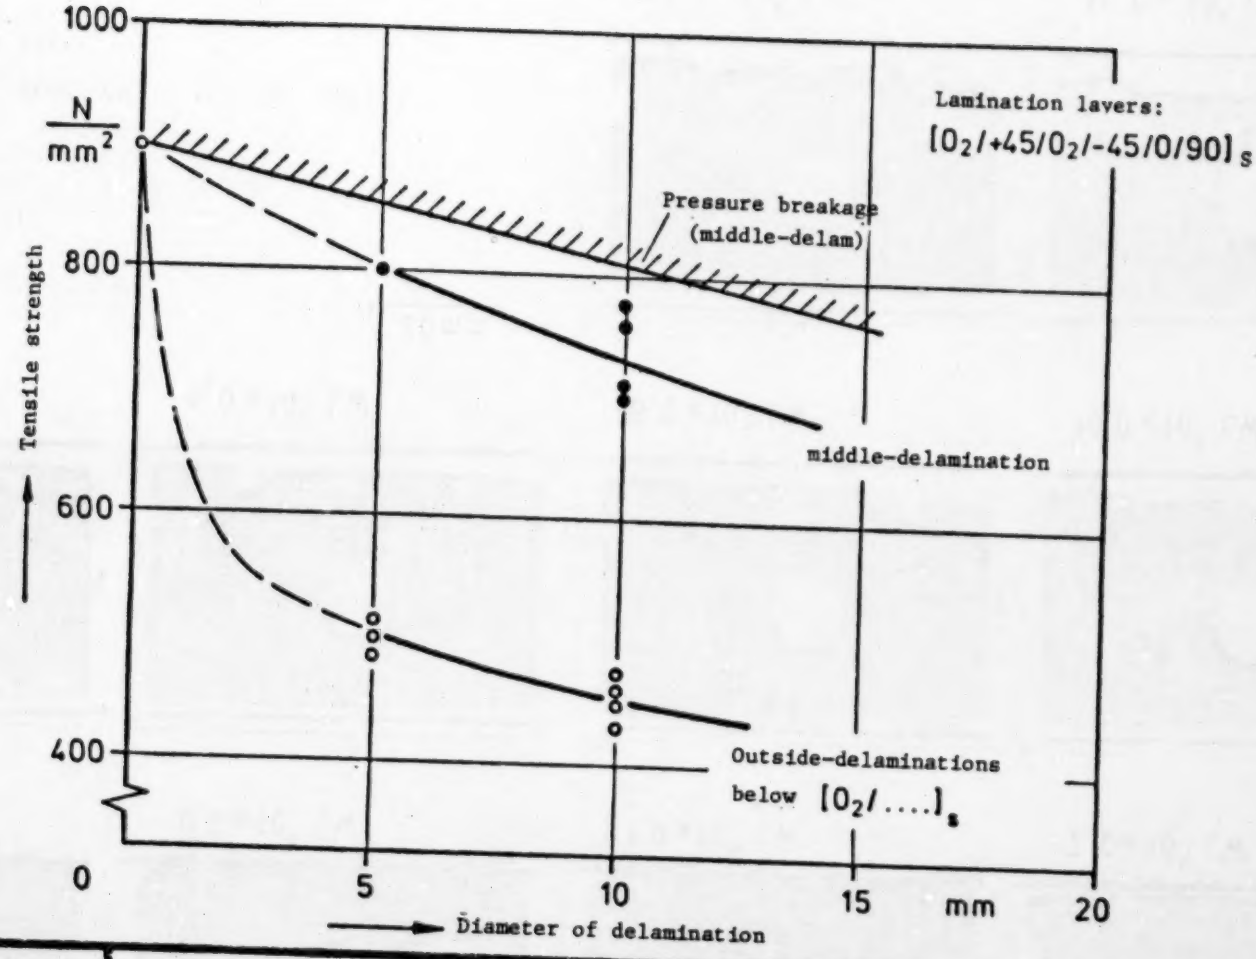
Fig. 19

Variations of the diameter of the delaminations or of their location within their stacking order, obviously, will produce different results. Figure 19 summarizes some of the accumulated test data which indicate that the size of the delaminations is less significant than their location. A ready explanation is the increasing tendency of the thinner of the separated section to buckle out and to thereby aggravate the state of stress at the perimeter of the delamination.

Influence of the delamination-amounton the spreading of delamination under compression loading.

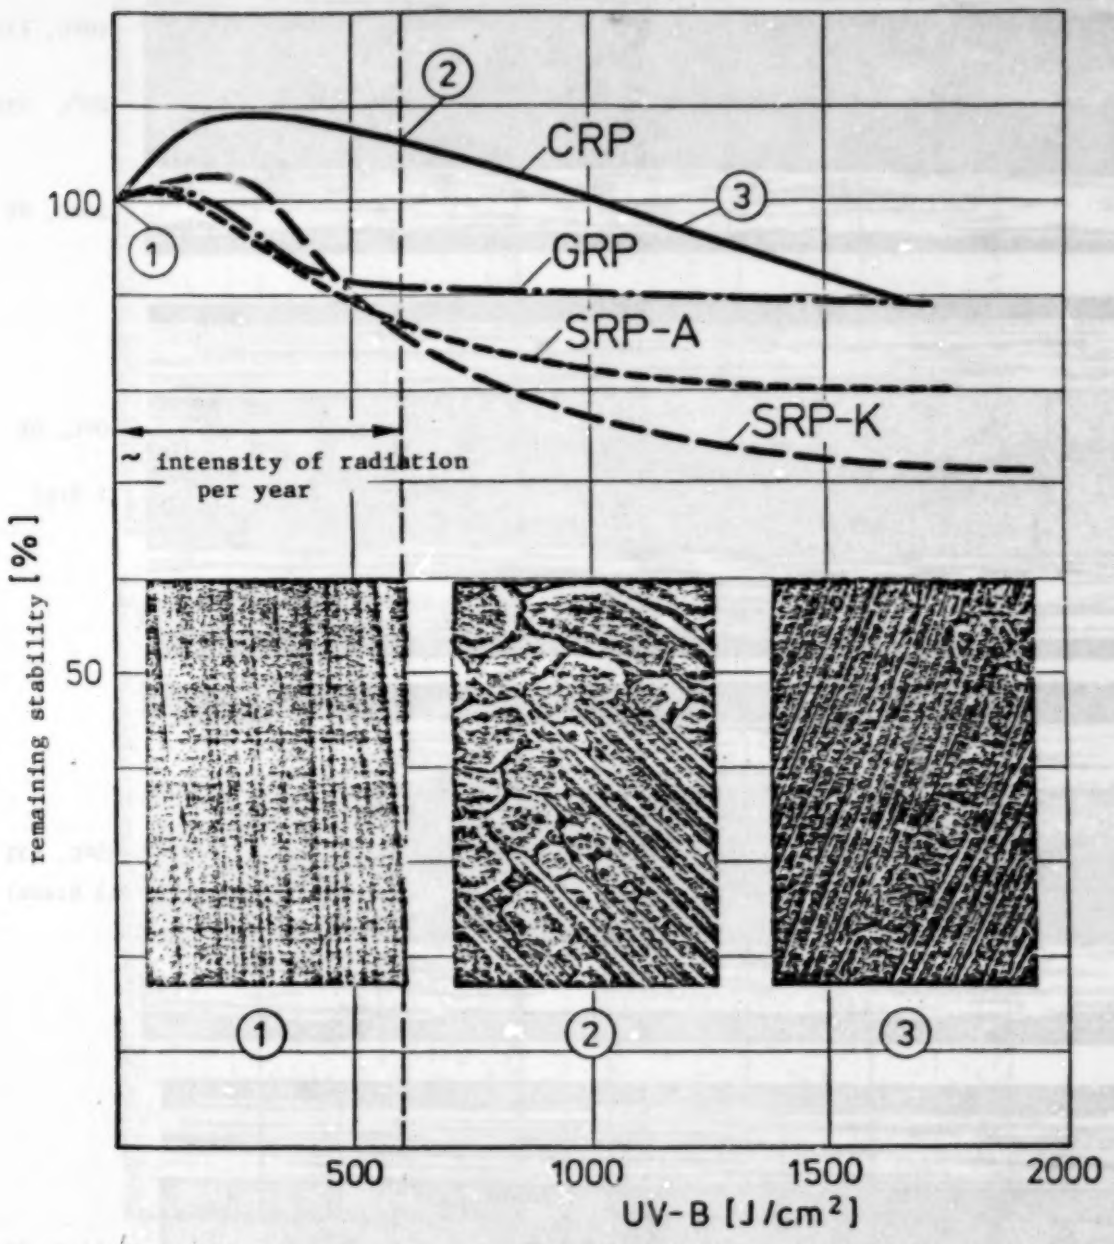
Fig. 22

A different kind of degradation occurs after prolonged exposure of epoxy laminates to ultraviolet radiation. According to Figure 22, a slight increase in strength, probably caused by postcuring of the resin, is followed by a gradual decrease as a consequence of the erosive deterioration of the laminate surfaces. As a point of interest it may be mentioned that epoxy laminates subjected to 3×10^8 rads of electron radiation, in vacuum, did not suffer degradation in strength or stiffness although the laminate surfaces exhibited a slight reddish tint.

Degradation caused by UV-B-radiation

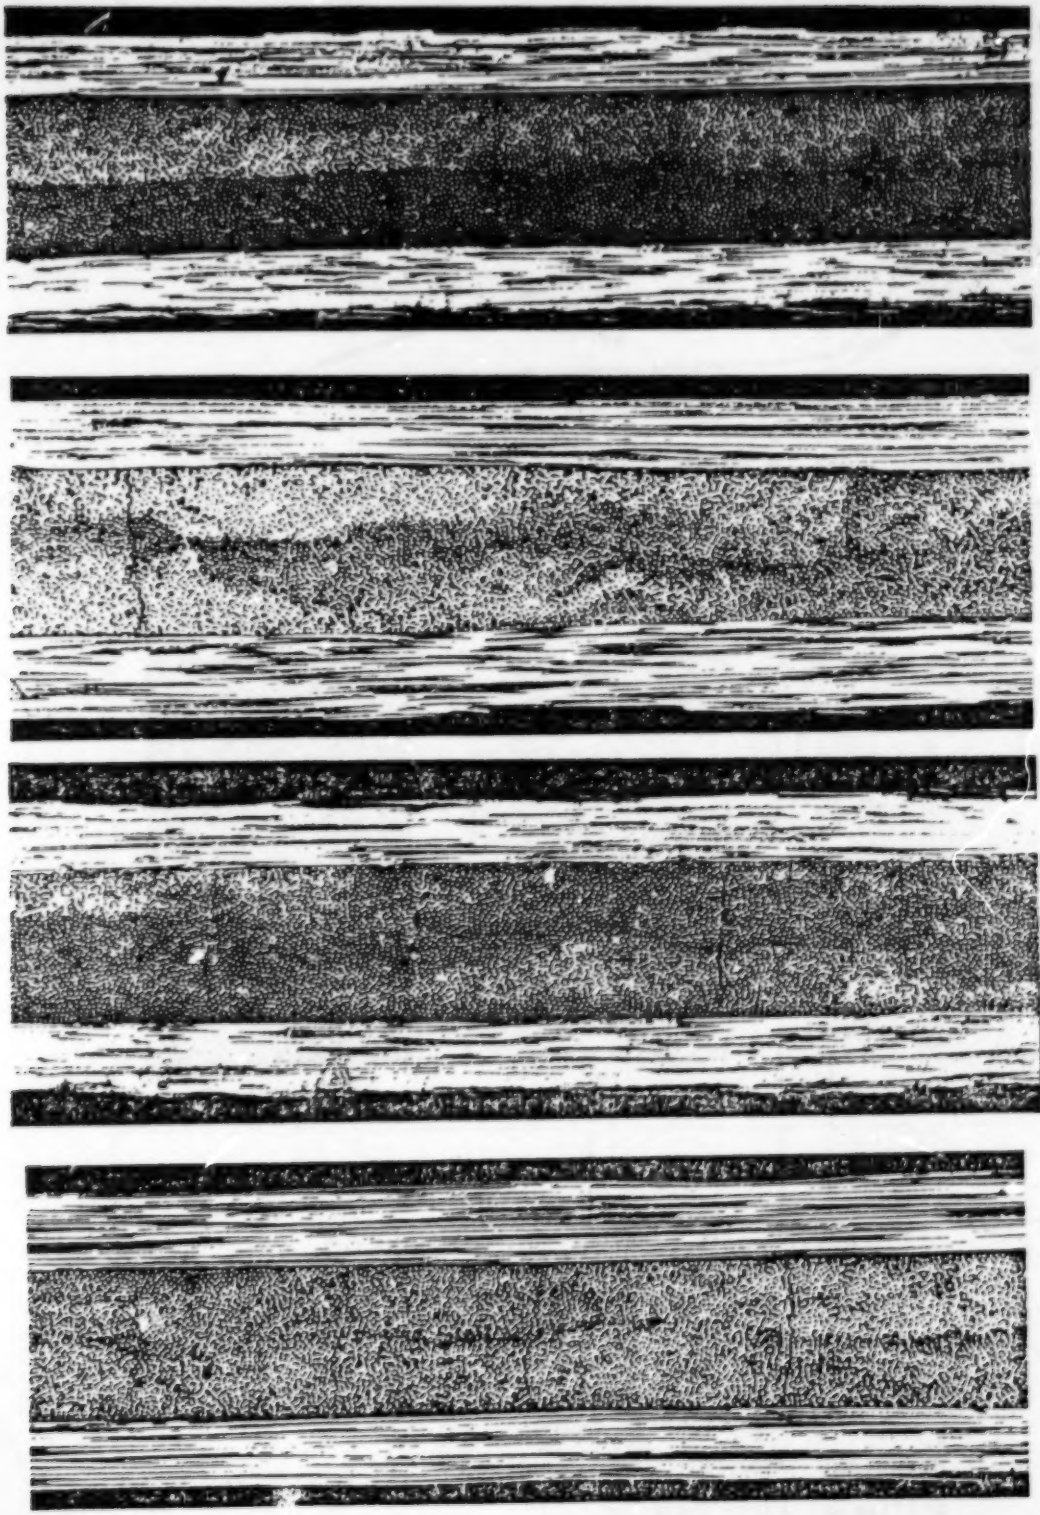
Fig. 23

Apart from laminate strength and stiffness, elevated temperatures as well as moisture affect significantly the strain capability of the epoxy resin. Figure 23 depicts the microcrack formation along the free edges of $[0,90]_s$-laminates tension-loaded to failure under different temperature and moisture conditions. In the dry state, the diminishing number of cracks at increasing temperature signals a higher degree of ductility, while in the moist state the onset of cracking is retarded by the relieving superposition of the swelling strains on the curing strains. From the damage-mechanical point of view it es essential that such considerations enter into the analysis of failure modes.

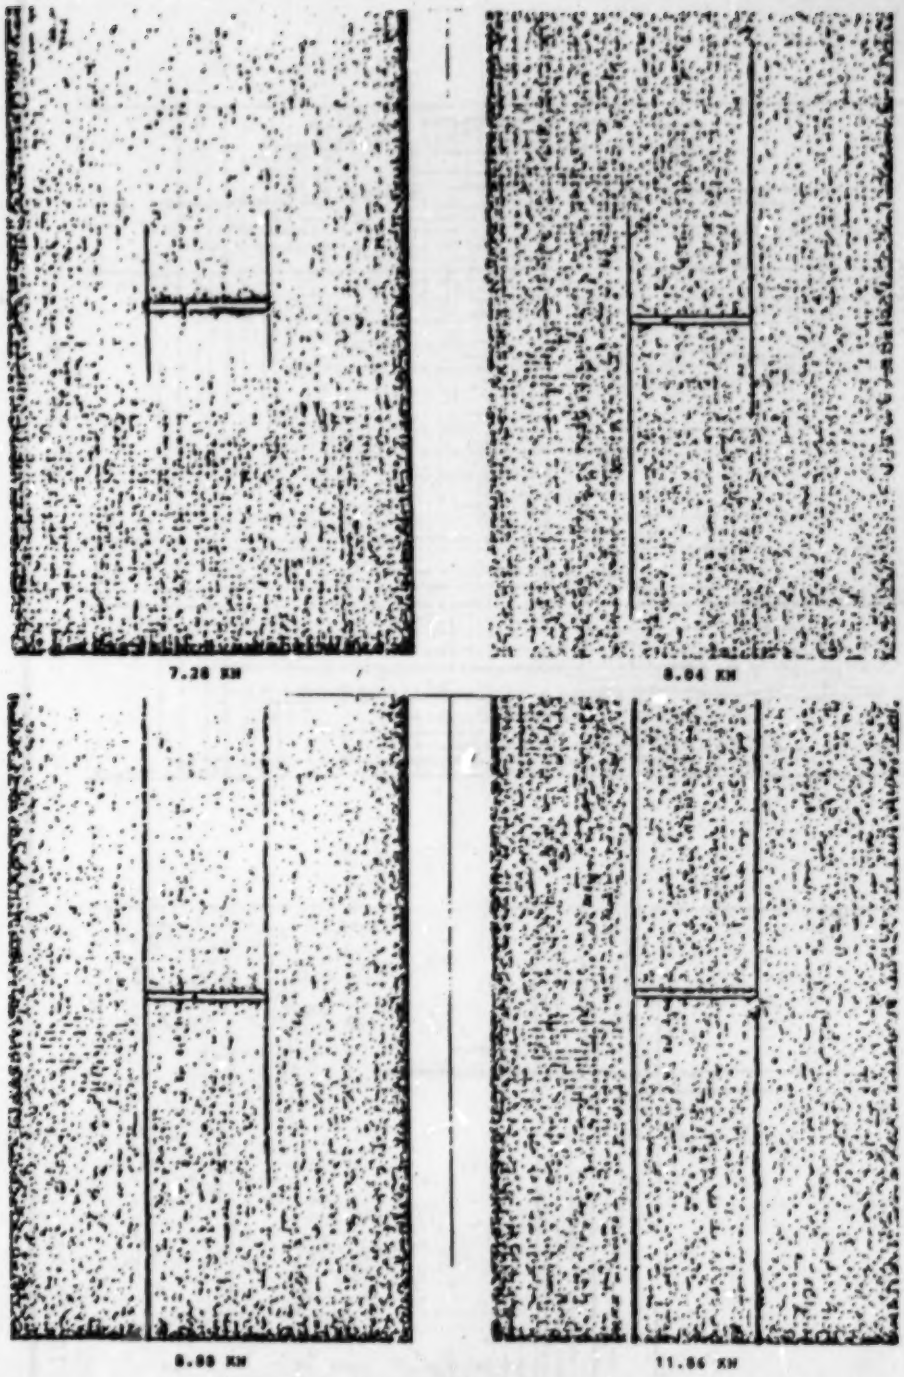
Fig. 24

A simple challenge to the validity of classical concepts is presented in Figure 24, showing a laminate with a transverse notch and unidirectionally oriented fibers. Fracture mechanical reasoning would idealize this laminate into an orthotropic plate with smeared homogeneity and, under static tensile load, expect a crack extension in the direction of the notch. In actuality the laminate behaves very differently. Emanating from the notch tips, cracks developing normal to the notch direction progress to the point of complete separation of the laminate with no growth in the notch direction at all.

Crackpropagation in a CFRP sample with internal notch

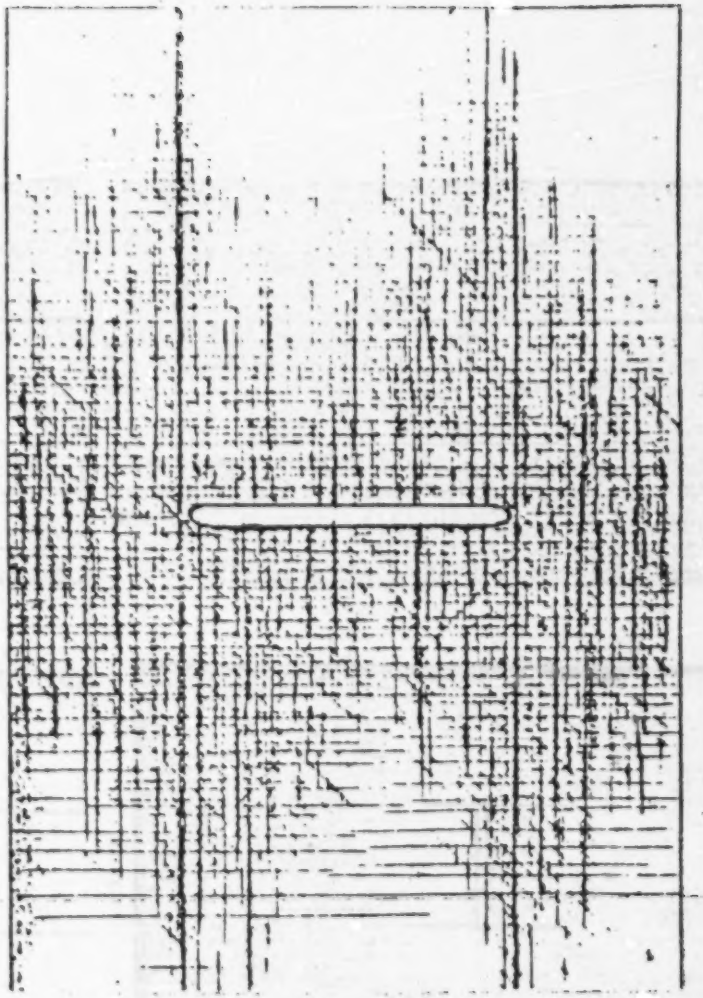
Fig. 25

In the case of fatigue loaded multidirectional specimens the resulting damage in the vicinity of holes or notches is considerably more complicated. Emanating from the notch tip or from the most highly stressed point on the periphery of the hole, cracks develop eventually in the fiber direction of each of the plies which increase in density and are followed by fiber ruptures, macrocracks and delaminations. Figure 25 and Figure 26 show examples of the damage zones at a notch tip and around a circular hole, respectively. It is difficult to conceive that this complex state of damage can be characterized by one or two empirically determined parameters. The problem assumes an even more challenging dimension when the holes are filled with mechanical fasteners and the damage state is affected by both bearing pressure and notch sensitivity.

10,20 kN

13,10 kN

Crackpropagation in a CFRP-sample with internal notch
